A New Case of Fracture of a Modular Femoral Neck Device After a Total Hip Arthroplasty

Klemens Trieb* and Nicola Stadler

Department for Orthopaedics, Klinikum Wels-Grieskirchen, Grieskirchnerstr. 42, A-4600 Wels, Austria

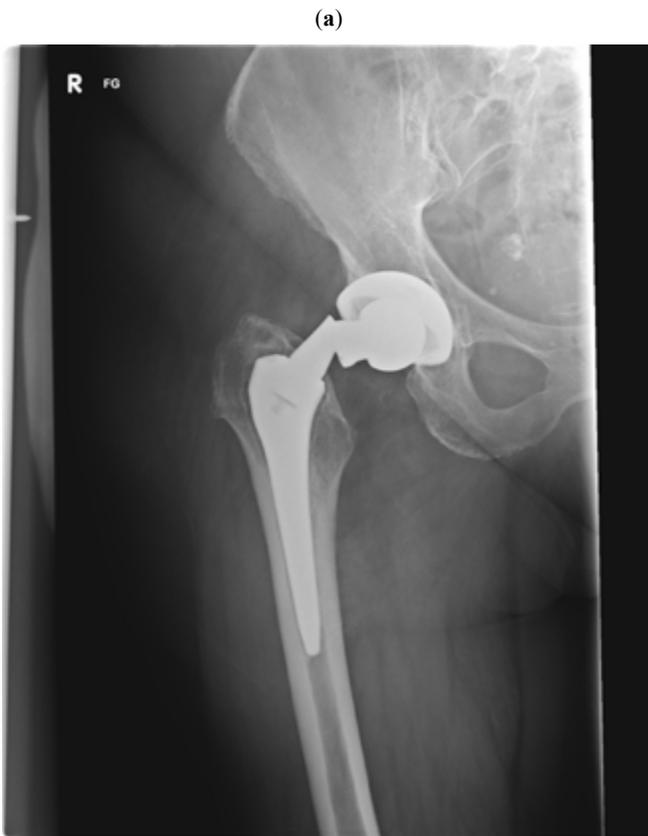
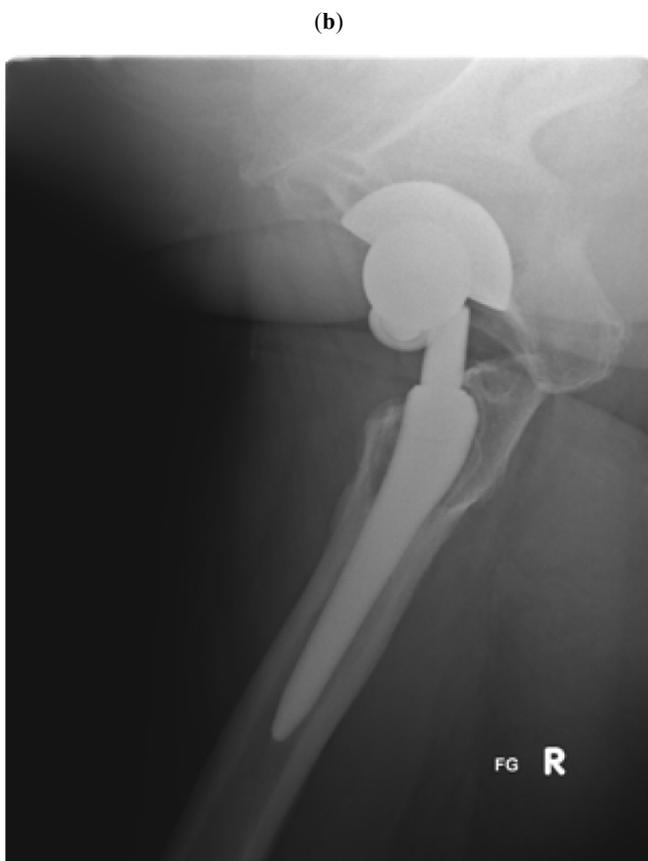
The breakage was proximal ant. the neck head junction, which has thus far not been described in the relevant literature (Fig. 1a, b). Therefore, the patient was transferred to our department in order to undergo a revision arthroplasty. The blood samples, which were taken preoperative, have not identified any infection. Also, the microbiological examination of the intraoperative smears and the biopsies which were taken have not shown any evidence of a bacterial joint inflammation.

Fig. (1). (a) preoperative X-ray a.p. (b) preoperative X-ray axial.

Our case represents a new mechanism because failure was not in the neck or on its basis. The breakage was proximal ant. the neck head junction, which has not yet been described in the literature.

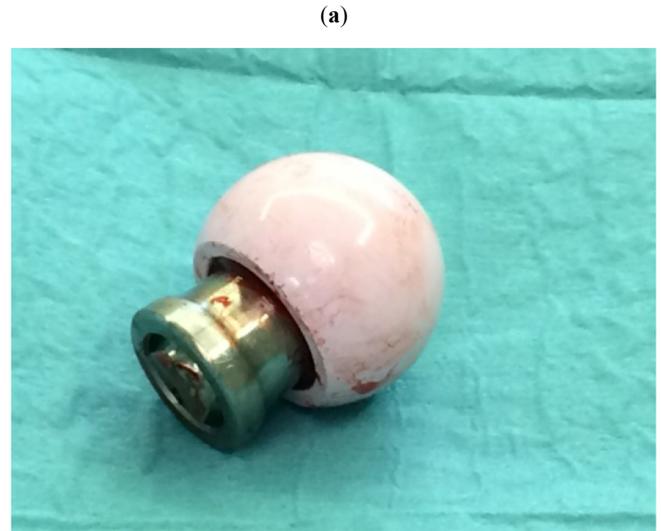
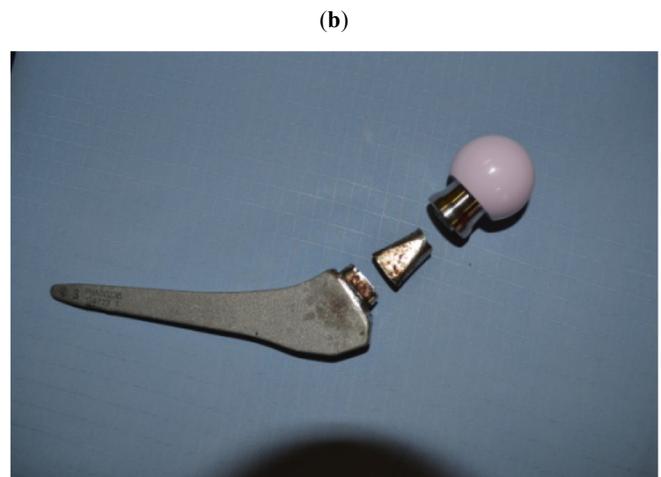
After having used an antero-lateral approach to the hip, the head and the proximal aspect of the neck were removed. We could not remove the distal aspect of the neck, which remained in the bore of the femoral stem (Fig. 2a, b). Therefore it was impossible to use a stem extractor. The intraoperative situs is shown in Fig. (4) presenting metallosis and inflammation. Our universal stem extractor was also unable to remove the implant, which is why an extended osteotomy was necessary to remove the femoral stem and the distal fragment of the modular neck. The patient received a cementless Alloclassic Zweymüller® SLL Revision Stem and BioBall® 3XL head. The extended osteotomy was fixed with the use of compression *cerclage Gundolf (CCG)*. The patient received blood supply through a haemoglobin drop. Postoperatively, she was allowed to bear weight of 15 kg (Fig. 3).

Fig. (2). (a) Explanted head: breakage proximal anterior the neck head junction, (b) Explanted prosthesis.

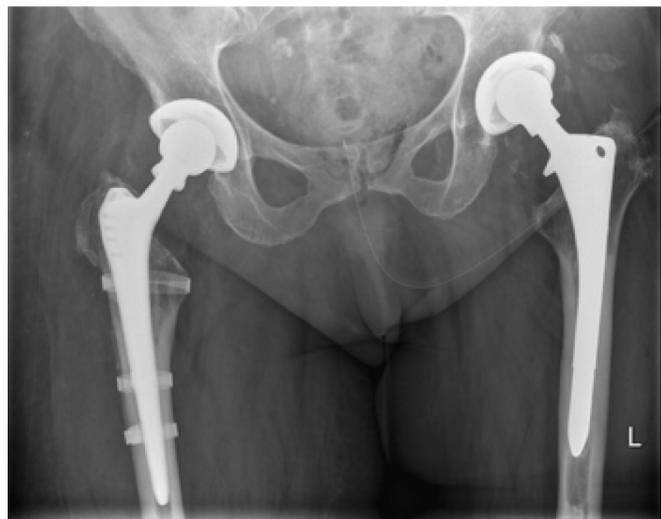
Fig. (3). Postoperative X-ray.

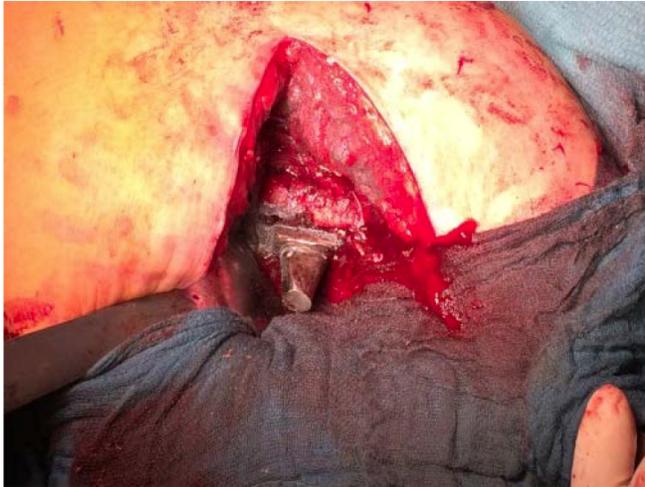
Fig. (4). Intraoperative picture of the soft tissue.
