# The Open Orthopaedics Journal

## CASE REPORT

# Highly Cross-linked Polyethylene Liner Dissociation from a Cementless Modular Acetabular Shell: Two Case Reports

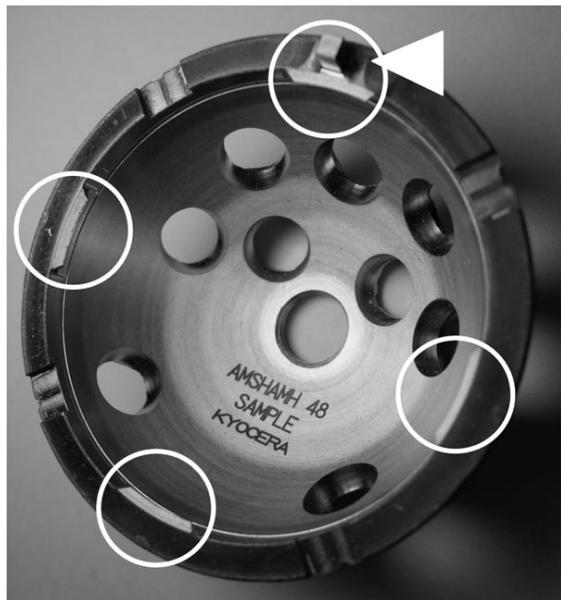
Fig. (1). Photograph showing the AMS-HA acetabular shell. Four nails for holding the polyethylene liner (four circle marks), and one prominently for rotation stability (arrow head mark).

AMS-HA acetabular shells have a problem with the liner fixing format, which may cause dissociation due to an enlarged femoral head, rim impingement, and declined strength at XLPE. Moreover, in recent years, a tendency has been observed for the femoral head to enlarge, with the same problem potentially occurring in other models, and it is believed that a strong locking groove fixing format is required.

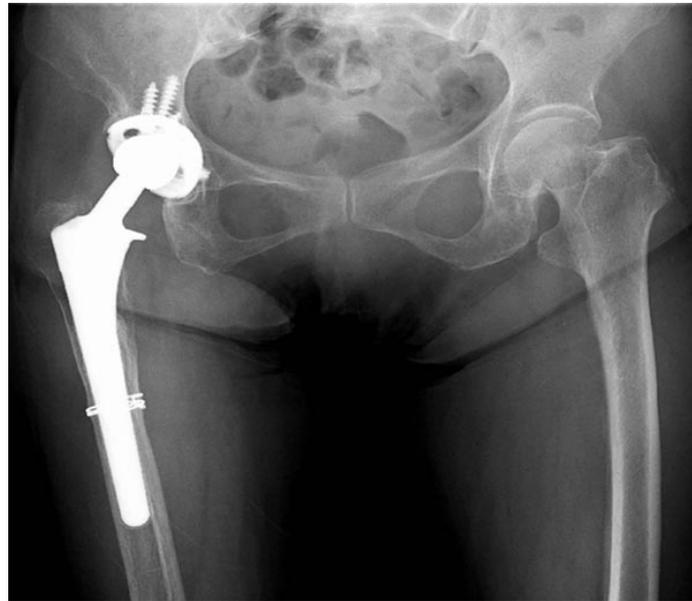
**Fig. (2a).** Photograph showing the Case 1. Nine years post-THA.

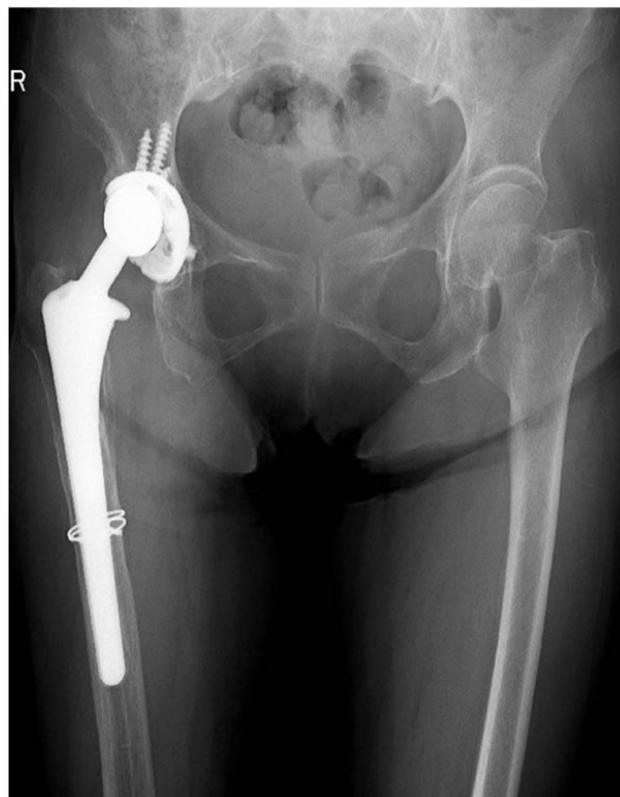
**Fig. (2b).** Nine years and eight months post-THA. Radiographs demonstrated supralateral subluxation of the right femoral head from the acetabular component, but there was no loosening of the acetabular or femoral implants.

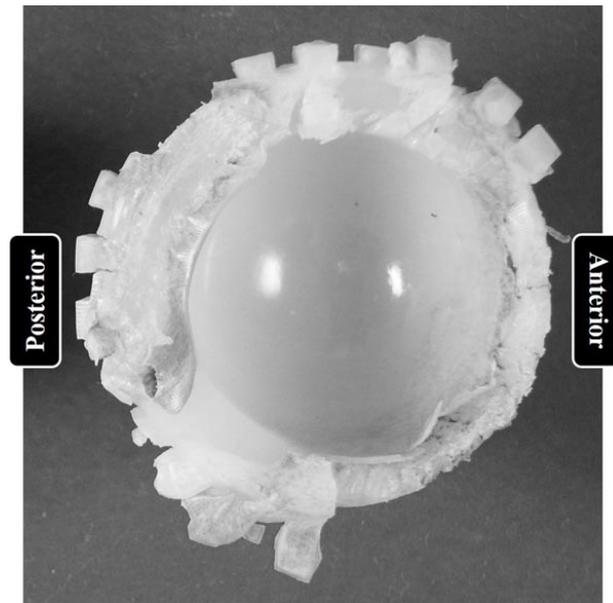
dislocation hip. An AMS-HA acetabular shell (outer diameter 44mm, inner diameter 38mm) with a cross-linked polyethylene (XLPE) liner was set in the acetabulum with four screws and a cementless proximal-hydroxyapatite-coated femoral component (a PerFix-HA #13-M stem) was used along with a 26 mm zirconia ball (Kyocera Medical, Osaka, Japan). An AMS-HA acetabular shell is a push in type liner fixing format for gripping the groove of a liner with four clicks, having a structure whereby rotatable fixation contributes to one section (Fig. 1). Regarding the XLPE liner, a calcium-stearate-free GUR 1050 ultra-high-molecular-weight PE resin was used to create a compression-molded sheet stock, which was then machined into the final implant geometry. Prior to machining, the compression-molded sheet was subjected to a process consisting of gamma-ray irradiation of 35 kGy in air to achieve the desired level of cross-linking and then annealed at 110 °C for 12 h in nitrogen to reduce the concentration of free radicals. After machining, the liners were sterilized with 25-kGy gamma-ray irradiation in nitrogen (total 60 kGy) and prepared [16, 17]. The gamma-ray irradiation amount of 60 kGy in total is similar to that reported in most previous studies using XLPE [18]. The inclination angle of the socket was 48 degrees, the anteversion angle was 26 degrees, the vertical distance from the tear drop to the center of the femoral head was 17 mm, and the horizontal distance was 22 mm. No problems were observed until 9 years following surgery (Fig. 2a); however, an aching pain and abnormal sound occurred in the right hip joint after 9 years and 8 months. A plain X-ray revealed that the right femoral head had deviated to the outer upper side of the acetabular socket; however, osteolysis was not observed in the vicinity of the acetabulum and femoral implant (Fig. 2b). Upon Surgery, the XLPE liner had dissociated inwards and downwards from the acetabular socket; however, no problems were observed in the four clicks, which is the liner gripping mechanism of the acetabular socket, with no looseness. Fixation of the femoral component was good with no macroscopic observation of the trunnion, and so revision surgery on the liner was conducted and the ball was exchanged. The extracted XLPE liner was observed with partial damage in the elevated rim on the alternative side and end section surface along with scratches on the back side (Figs. 2c and 2d, Table 1).

**Fig. (2c).** The removed acetabular liner that looking alternative side view.

Alternative side		Back side	
	Anterior side	Posterior side	Anterior side	Posterior side
Case 1	Surface of the end face is crushed due to friction with the stem neck following dissociation, which is believed to have caused exfoliation in some areas	Partial damage to the elevate rim and end face surface	Partial scratches from the click of the shell in the upper center	Belt-like scratch marks caused by the click of the shell occurring in the process leading to dissociation

was caused following dissociation; however, the elevated rim of the XLPE liner remained in Case 1, suggesting that dissociation occurred first at least in Case 1, and we concluded that dissociation of the XLPE liner occurred due to sinking of the posterior side inside the shell and rotating of the anterior side downwards, thereby causing friction between the liner and stem neck at the bottom part after dissociation.

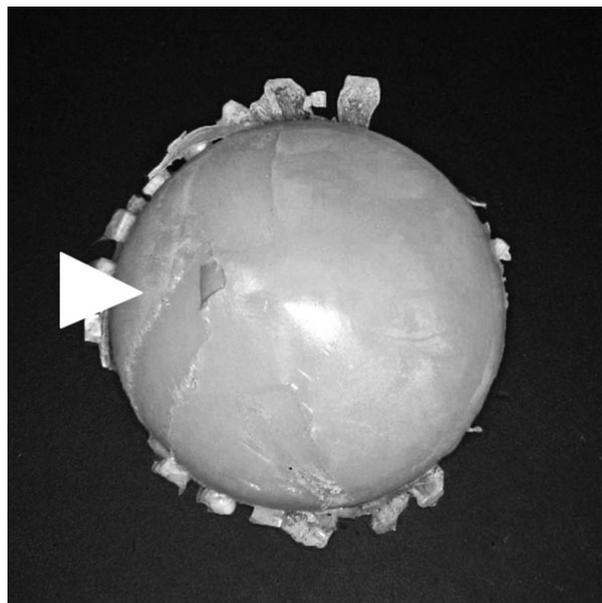
**Fig. (2d).** The removed acetabular liner that looking back side view. There is scratch by folding nail of liner (arrow head mark).

There have been several reports on PE liner dissociation from cementless acetabular shells regarding Harris-Galante cementless prostheses. Harris-Galante cementless prostheses are considered problematic in that the PE liner is fixed by gripping the cementless acetabular shell with tines using a push in type liner fixing format [1 - 6]. Gonzalez Della Valle *et al.* mentioned that dissociation of the PE liner of Harris-Galante cementless prosthesis occurs *via* the following three mechanisms: (1) damage due to fatigued tines in titanium sockets; (2) increased micro motion in the socket liner interface; and (3) impingement of the stem neck and liner border [3]. The fixing formats of PE liners to cementless acetabular shells include push in, ring lock, locking groove, *etc.*; however, the liner fixing format of push in and ring lock have come to be considered problematic due to their weak fixing force, and so the locking groove fixing format is recommended [20]. The configuration involving gripping the groove of the PE or XLPE liner with four clicks of the AMS-HA acetabular shell is also a push in type liner fixing format similar to Harris-Galante cementless prostheses, and it is believed that there was a problem with this fixing mechanism. Upon finite element method analysis of the present model, it was found that force concentrated in the clicking part, leading to a loss in the locking machinery when the groove of PE liner is damaged and ultimately causing dissociation. The size of the force is affected by the thickness of the PE liner, with the force increasing as the PE thins. In the present model, no dissociation of the PE liner has been observed in cases using a 22 mm femoral head; however, many cases of dissociation have been observed with sandwich type ABS liners, and it is surmised that the liner thickness is involved in the occurrence of dissociation. Scratch marks from the gripping click have been observed on the back side upon analysis of extracted PE liners, and it is surmised that force concentrated on the clicking part of the liner gripping, causing the locking machine of the clicking part to gradually break, leading to dissociation. Moreover, increased load due to increased alternative torque accompanying enlargement of the femoral head and the structural problem of the rotatable fixation contributing to one area are also believed to cause micro motion and back side wear, which may have enhanced polyethylene liner dissociation.

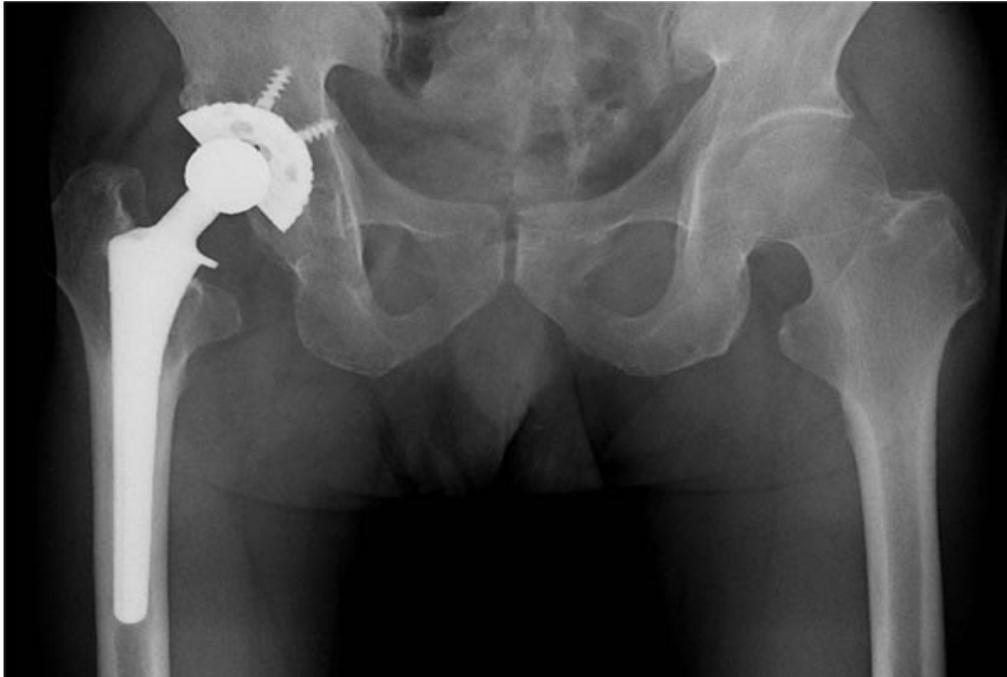
**Fig. (3a).** Only Figure 3: Photograph showing the Case 2. Nine years post-THA.

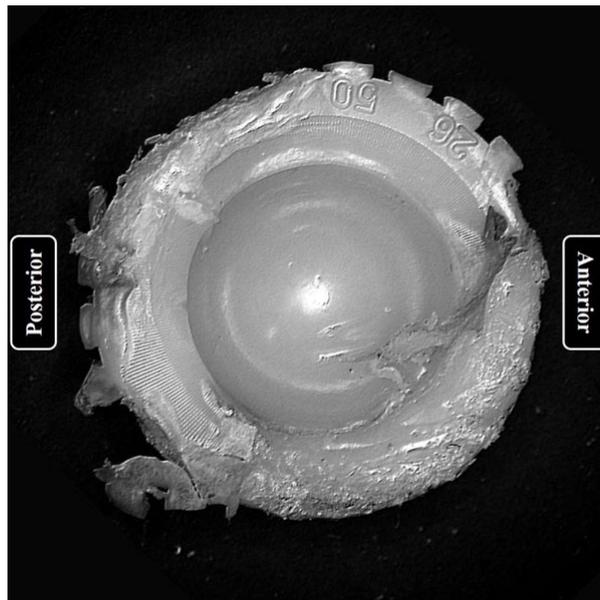
extracted XLPE liner was observed with partial damage in the elevated rim of the alternative side and end section surface along with scratches on the back side (Fig. 3c and 3d, Table 1).

**Fig. (3c).** Nine years and ten months post-THA. Radiographs demonstrated supra-lateral subluxation of the right femoral head from the acetabular component, but there was no loosening of the acetabular or femoral implants. Removed acetabular liner that looking alternative side view.

Alternative side		Back side	
	Anterior side	Posterior side	Anterior side	Posterior side
Case 2	Surface of the end face is crushed due to friction with the stem neck following dissociation, which is believed to have caused exfoliation in some areas	Partial damage to the elevate rim and end face surface	Partial scratches from the click of the shell in the lower center	Scratch marks throughout a large area caused by the click of the shell occurring in the process leading to dissociation

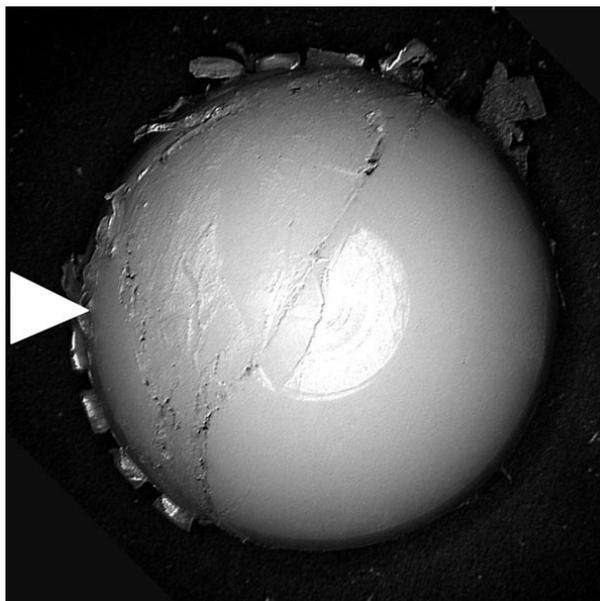
**Fig. (3d).** Removed acetabular liner that looking back side view. There is scratch by folding nail of liner. (arrow head mark).
