Traumatic Ceramic Femoral Head Fracture: An Initial Misdiagnosis

Abstract: *Background and Purpose:* Ceramic heads are widely used in modern total hip arthroplasty (THA). Although a rare complication, fractures of ceramic heads are described in the literature, evoking uncertainties regarding the *in vivo* stability of this material, especially when impaction of a fractured ceramic head can lead to disastrous results.

Methods: In this case report, we present a fracture of a ceramic head after trauma. A misinterpretation of the initial radiographs led to severe fragmentation of the ceramic head two weeks after the incident, later resulting in complete destruction of the arthroplasty.

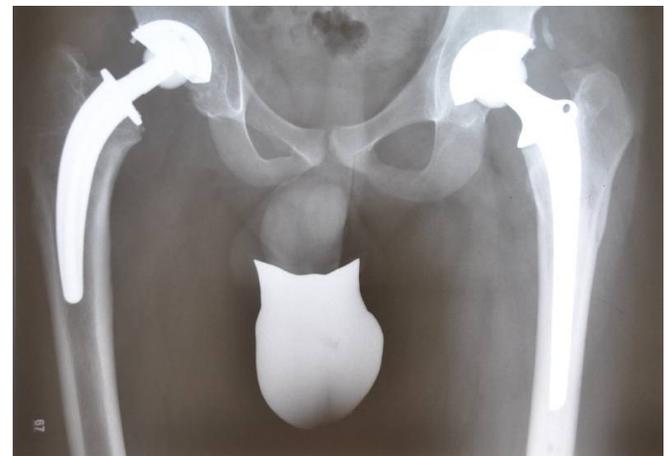
Fig. (1). Anteroposterior pelvic radiograph (24 year old male) after primary THA for secondary osteoarthritis due to Perthes disease (Right Hip: cementless CFP stem and TOP acetabular cup; Left Hip: Hybrid THA with cemented ENDO Mark III stem + cementless TOP acetabular cup, Waldemar Link GmbH, Hamburg, Germany).

A 24-year old patient with secondary osteoarthritis of the hips due to Legg-Calve-Perthes disease underwent primary hybrid THA of the left hip seven years before trauma, followed by primary cementless THA of the right hip one year later at our institution (Fig. 1) Six years after the right THA, he was involved in a motorcycle accident, in which he suffered direct trauma to this hip, as well as a complex ankle

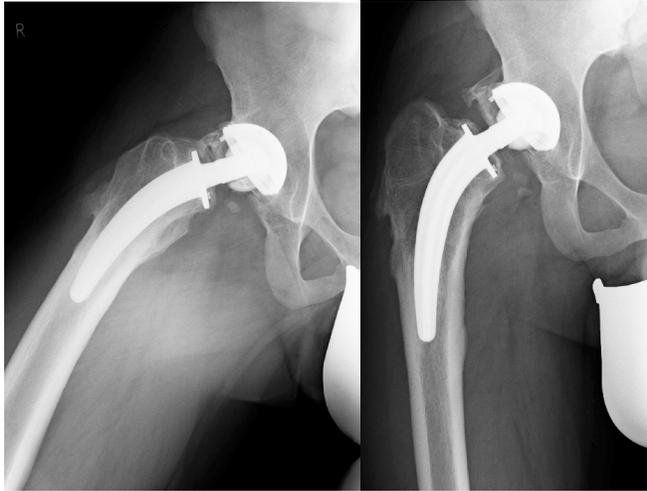
fracture which was treated in a smaller regional hospital on admission. Although initial anteroposterior radiographs of the pelvis and right hip axial views were performed, no signs of fractures, aseptic loosening or implant damage were diagnosed by the attending trauma surgeons (Fig. 2). Two weeks after surgical treatment of the ankle fracture, the patient noticed a sudden “cracking” sound in his right hip, as well as shortening of the right lower limb. Interestingly, the patient had no relevant pain.

Fig. (2). Conventional pelvic radiographs directly after trauma, revealing ceramic head fracture.

Although a relatively rare complication in modern THA, the described ceramic head fracture was misinterpreted in initial radiographs, which showed a discreet fracture of the ceramic head. Two assumptions can be made which led to this misdiagnosis. Firstly, the complex ankle fracture was probably more painful than the ceramic head fracture and this misled the surgeons. Secondly, which is more fact than assumption, is that the initial center of admission was incapable of reaching the correct diagnosis when one

considers that the initial radiographs revealed a ceramic head fracture.

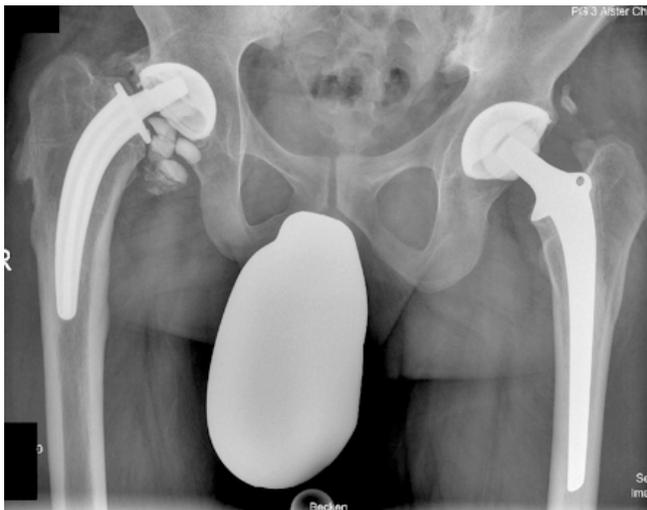
Fig. (3). Anteroposterior pelvic radiograph eight months after the initial radiographs, showing a fractured ceramic head.

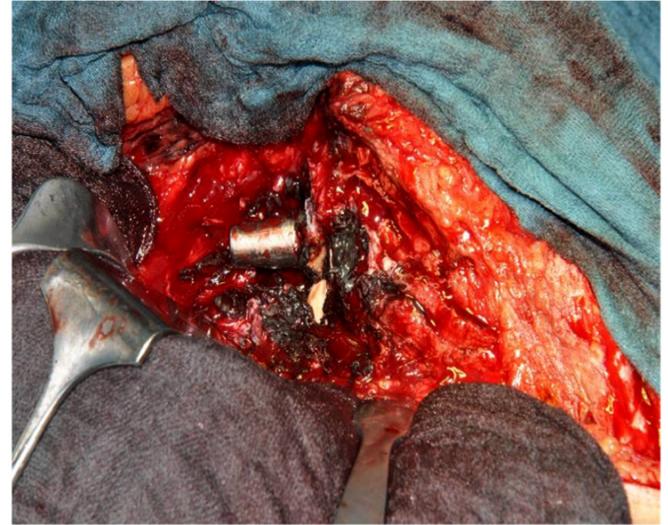
Intraoperatively, extensive damage of the ceramic head and correlating taper junction of the femoral neck was found (Figs. 4, 6, 7). Concomitantly, there was severe debris-related metallosis throughout the entire joint (Fig. 5). The intervention consisted of conversion of the short cementless CFP stem to a cementless revision stem and an acetabular cup revision to a ceramic-ceramic bearing surface (Alloclassic stem and Allofit-IT acetabulum with Delta Ceramic Inlay, Zimmer, Warsaw, Indiana, USA and Ceramtec, Plochingen, Germany). Meticulous debridement of all affected soft tissues and extensive lavage was additionally performed.

Fig. (4). Intra-operative image showing countless debris and the damaged taper junction of the femoral neck (*in situ*).

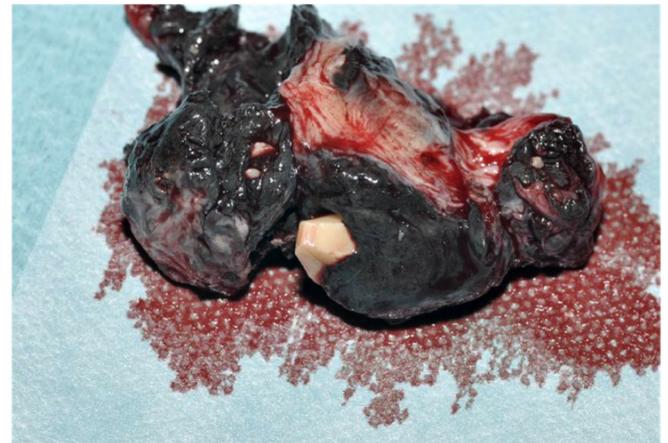
Fig. (5). Intra-operative image showing debris with ceramic fragments.

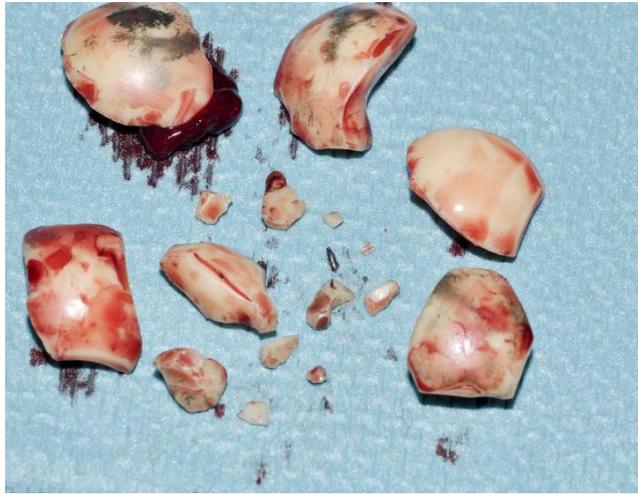
Fig. (6). Intra-operative image showing the fragmentation of the ceramic head.

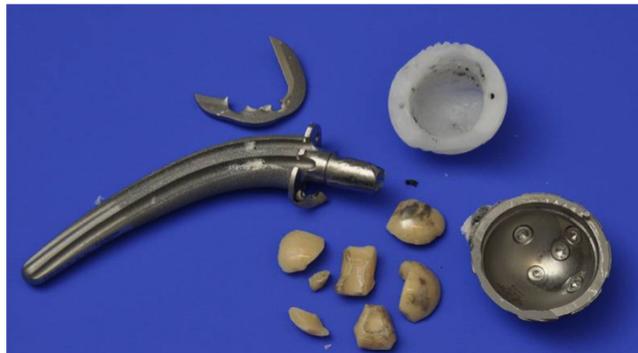
Fig. (7). Image showing the explanted components: a fragmented ceramic head, a damaged stem and acetabular cup and liner.

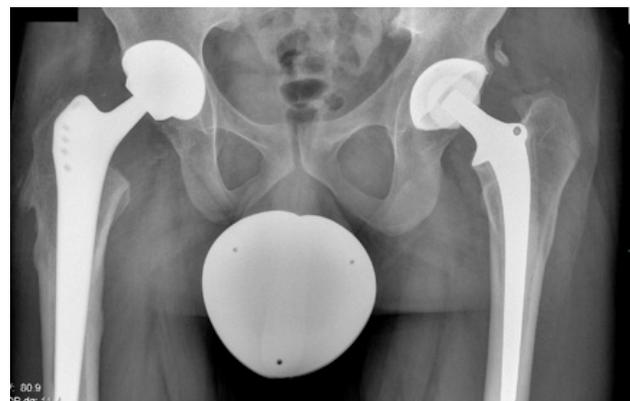
The postoperative course was uneventful, with radiographs revealing a correct position and articulation of the cementless implant (Fig. 8). A 12 month postoperative inquiry was performed and the Oxford Hip Score obtained, with both indicating satisfactory joint function [14]. The patient had no pain and was able to perform his daily activities.

Fig. (8). Postoperative anteroposterior pelvic radiograph.
