The Open Orthopaedics Journal

RESEARCH ARTICLE

Immediate Postoperative Portable Radiograph After Total Knee Replacements: A Necessity or a Burden?

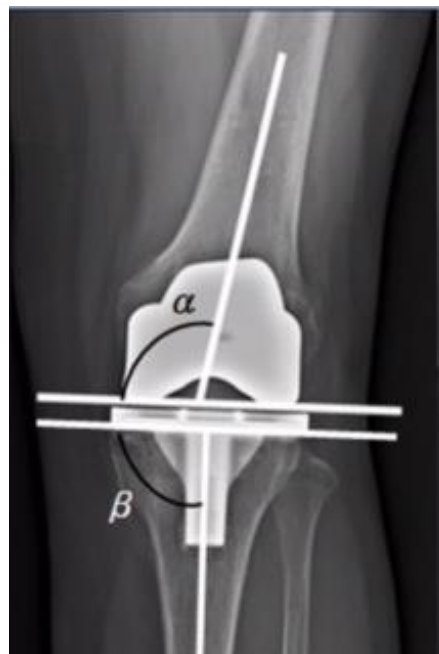
Fig. (2). Methods of coronal angle measurements on AP views.

Femoral component coronal alignment = 90 - alpha

Tibial component coronal alignment = 90 - beta

The images were also assessed for their capability of evaluating implant positioning [8 - 10]. The component alignment angle of the knee implant was measured for both the femoral component and the tibial component in both the AP and the lateral views. The femoral component and the tibial component coronal alignment was measured on the portable and radiology suite radiographs in the AP views. Femoral alignment was calculated by drawing a tangent to the distal femoral condyles and a line along the femoral anatomical axis and then measuring the angle subtended. Tibial alignment angle is calculated by drawing a tangent across the tibial base plate and drawing a line along the anatomical axis of the tibia [11 - 14]. The purpose of measuring the anatomical axis was to determine if the images of the portable radiographs could provide measurements as accurate as those provided by the images taken in the radiological suite. The anatomical axes of the tibia and femur were drawn as a line best bisecting the respective medullary cavities. Next we reviewed all the patients' records to identify if any changes were made in their management plan based on findings discovered in the postoperative portable radiographs. This was completed to evaluate the necessity of the immediate postoperative portable radiographs. The same surgeon in our center performed all total knee replacements. The prostheses used in our total knee replacements were the Genesis and Genesis 2 (Smith & Nephew, London, United Kingdom). The brands of the portable radiography machines were Siemens mobile tt XP digital (Digital film, Settings: 56 kVp, 5 mAs) and GE optima Hualun Medical Systems (Digital Film, Settings: 70 kVp, 4 mAs). Both these devices required the operator to adjust the distance from the patient's knee. In the radiology suite the machines were General Electric (Digital Film, Settings: 70 KVp, 5.0 mAs, 250 mA, 20 msec) and Siemens axiom Aristos FX plus (Digital Film, 63 KVp, 5mAs, 500 mA). Here the radiographs were performed in a supine position with a fixed distance of 100 cm from the patient's knee. All images had 15% magnification. The cost of the post-operative radiographs was obtained from our hospital's cost-billing department. Transport services, x-ray technician time, repeated radiographs, and
