The Open Orthopaedics Journal

RESEARCH ARTICLE

Immediate Postoperative Portable Radiograph After Total Knee Replacements: A Necessity or a Burden?

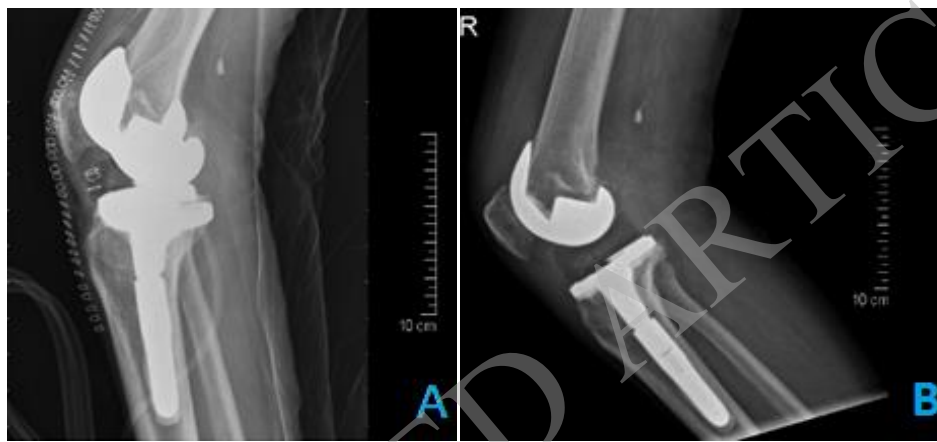
Fig. (1). A comparison of the recovery room radiographs (A) vs. radiology suit radiograph (B) in the same knee demonstrates an inferior quality of the recovery room radiograph (A).

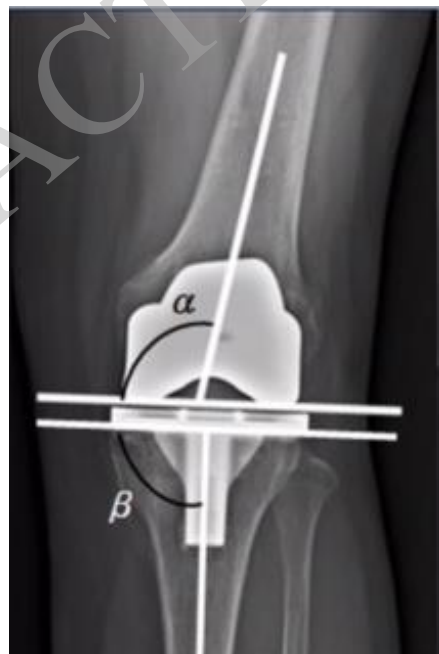
Fig. (2). Methods of coronal angle measurements on AP views.

Femoral component coronal alignment = 90 - alpha

Tibial component coronal alignment = 90 - beta

The images were also assessed for their capability of evaluating implant positioning [8 - 10]. The component alignment angle of the knee implant was measured for both the femoral component and the tibial component in both the AP and the lateral views. The femoral component and the tibial component coronal alignment was measured on the portable and radiology suite radiographs in the AP views. Femoral alignment was calculated by drawing a tangent to the distal femoral condyles and a line along the femoral anatomical axis and then measuring the angle subtended. Tibial alignment angle is calculated by drawing a tangent across the tibial base plate and drawing a line along the anatomical axis of the tibia [11 - 14]. The purpose of measuring the anatomical axis was to determine if the images of the portable radiographs could provide measurements as accurate as those provided by the images taken in the radiological suite. The anatomical axes of the tibia and femur were drawn as a line best bisecting the respective medullary cavities. Next we reviewed all the patients' records to identify if any changes were made in their management plan based on findings discovered in the postoperative portable radiographs. This was completed to evaluate the necessity of the immediate postoperative portable radiographs. The same surgeon in our center performed all total knee replacements. The prostheses used in our total knee replacements were the Genesis and Genesis 2 (Smith & Nephew, London, United Kingdom). The brands of the portable radiography machines were Siemens mobile tt XP digital (Digital film, Settings: 56 kVp, 5 mAs) and GE optima Hualun Medical Systems (Digital Film, Settings: 70 kVp, 4 mAs). Both these devices required the operator to adjust the distance from the patient's knee. In the radiology suite the machines were General Electric (Digital Film, Settings: 70 KVp, 5.0 mAs, 250 mA, 20 msec) and Siemens axiom Aristos FX plus (Digital Film, 63 KVp, 5mAs, 500 mA). Here the radiographs were performed in a supine position with a fixed distance of 100 cm from the patient's knee. All images had 15% magnification. The cost of the post-operative radiographs was obtained from our hospital's cost-billing department. Transport services, x-ray technician time, repeated radiographs, and
